HISTORIC AND DESIGN REVIEW COMMISSION

HDRC CASE NO: 2022-079
COMMON NAME: Brackenridge Park
ADDRESS: 3700 N ST MARYS ST
ZONING: R-6,HS
CITY COUNCIL DIST.: 2
LANDMARK: Individual Landmark
APPLICANT: Jamaal Moreno/City of San Antonio - PWD
OWNER: City of San Antonio - PWD
TYPE OF WORK: Removal of heritage and significant trees at top of bank and along the river
APPLICATION RECEIVED: January 28, 2022
60-DAY REVIEW: *Not applicable*

Brackenridge Park Tree Preservation & Removal

TREE PROTECTION AND
DEMOLITION PLAN

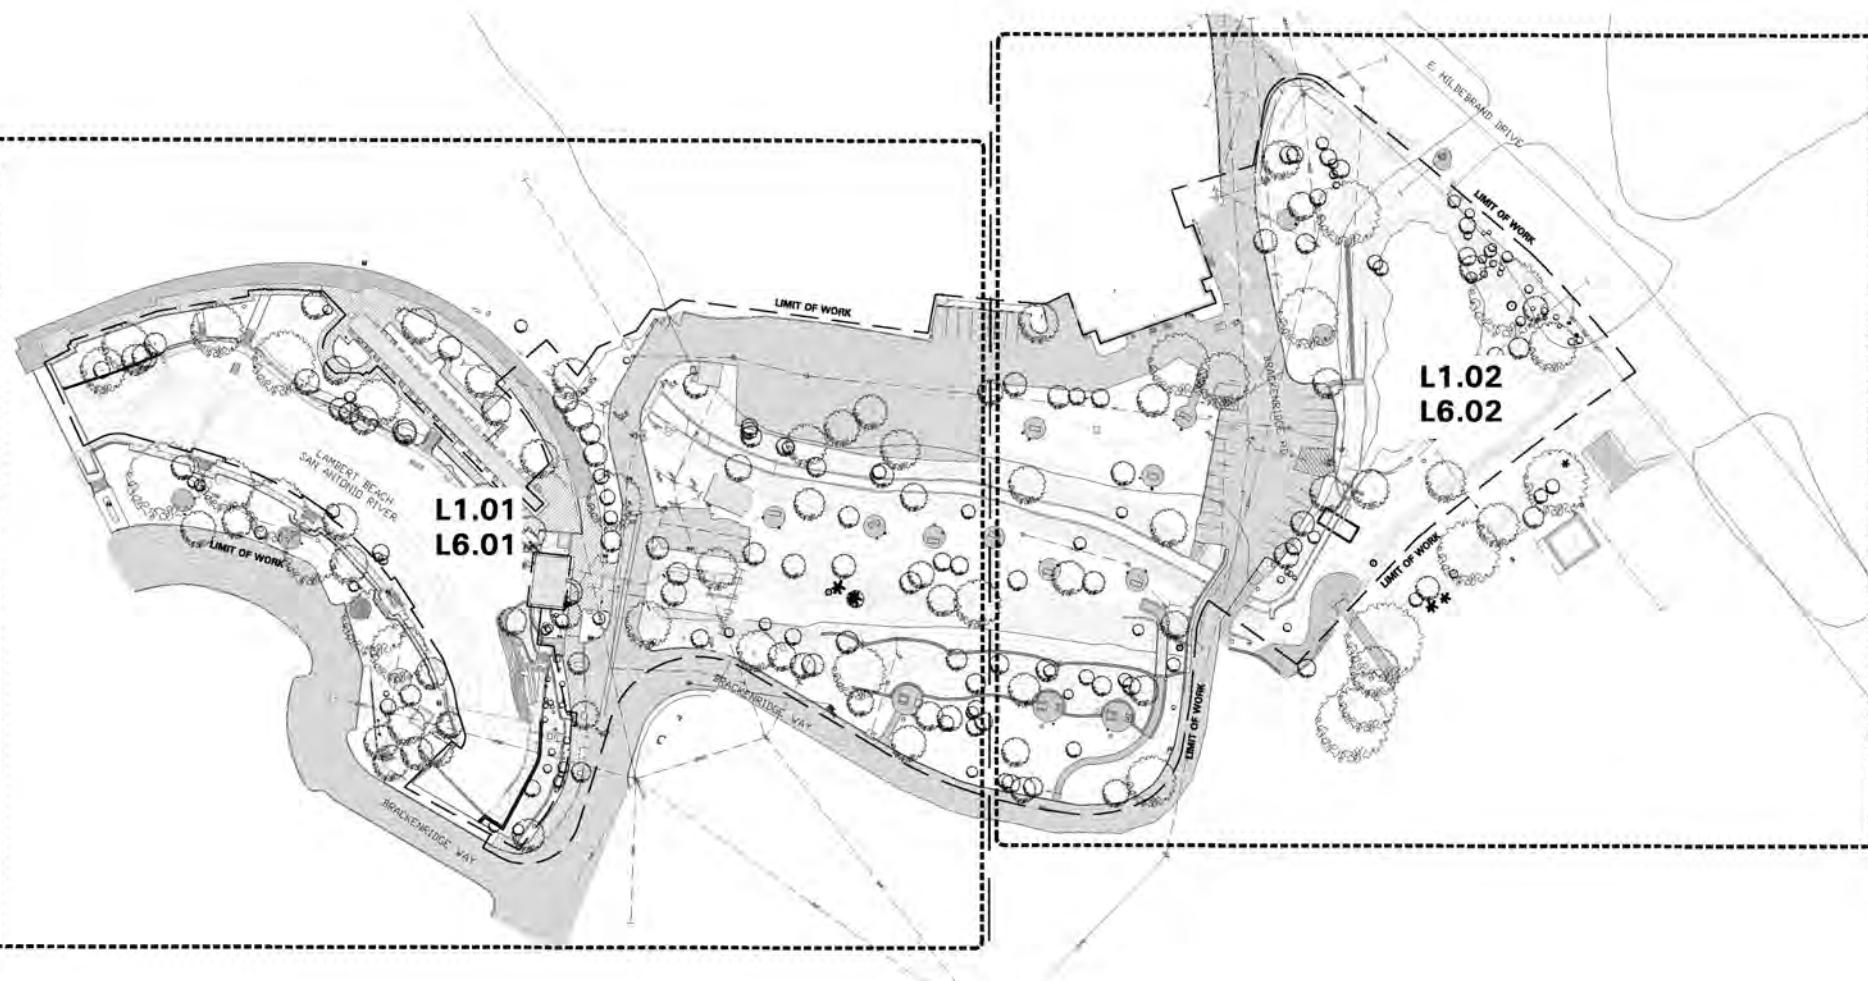
Trees Preserved.....	136 (30 heritage)
Native species Trees Removed.....	105 (10 heritage)
Invasive species/dead trees removed.....	23
Trees to be planted for improvement project....	200+
Trees to be planted elsewhere in the park.....	200-400

*For preservation/mitigation purposes within the floodplain and environmentally sensitive areas (ESAs), per UDC, all trees 2 inches in caliper and above are considered significant, large species trees 24 inches and above are considered Heritage.

Cultural Resources/Historic Structures Within the project area

1. Lambert Beach River Walls
2. Lambert Beach Steps
3. Brackenridge Pumphouse (Waterworks Bldg.)
4. Upper Labor Diversion Dam
5. Upper Labor Acequia
6. Restroom Building
7. Donkey Bridge

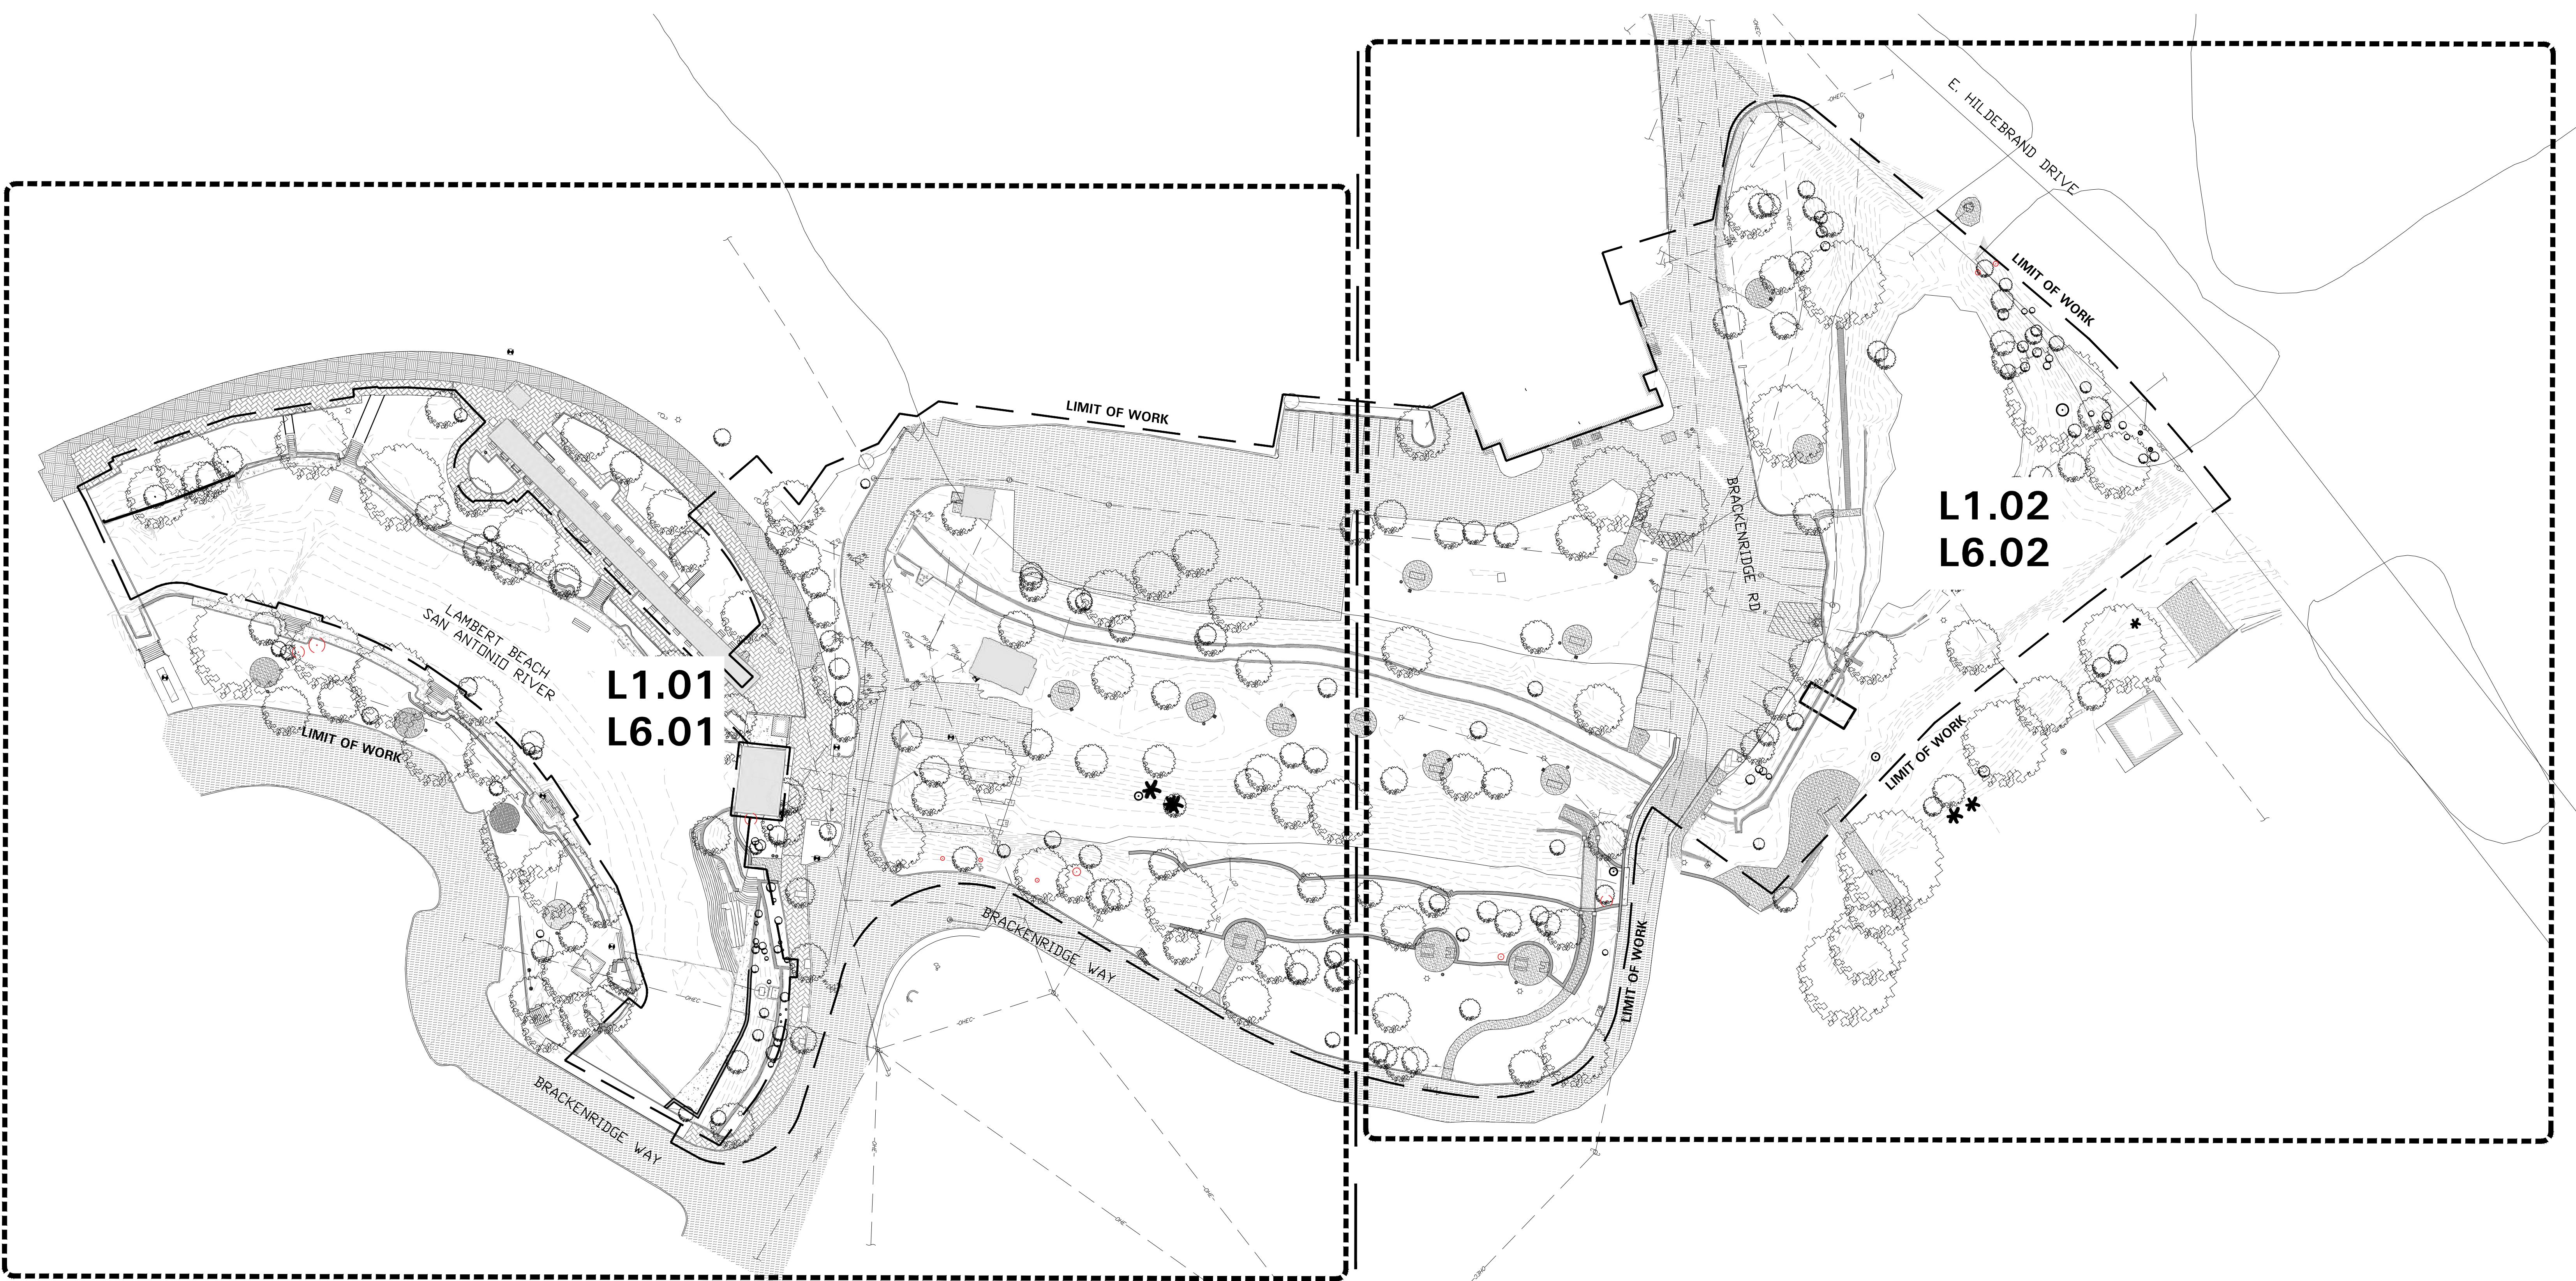
- "TREES TO BE REMOVED UNDER HISTORIAN OVERSIGHT" PER LEGEND WILL REQUIRE A HISTORIAN (PROVIDED BY PWD EMD) TO BE PRESENT BEFORE REMOVAL ACTIVITIES CAN BEGIN.

- DO NOT STAGE EQUIPMENT ON OR NEAR HISTORIC RIVER WALLS OR HISTORIC STRUCTURES. EXACT DISTANCE WILL DEPEND ON CONDITION OF HISTORIC STRUCTURE. SUPPORT WILL BE PROVIDED BY THE MONITOR ON SITE.

- IF HEAVY EQUIPMENT (SKID LOADER AND UP) IS TO BE USED NEAR A HISTORIC STRUCTURE, USE EDM APPROVED METHODS OF PROTECTION. CONTACT THE PWD EMD ARCHITECTURAL HISTORIAN (210-207-1454) FOR GUIDANCE.

- NO MACHINERY SHOULD BE DRIVEN ON TOP OF THE UPPER LABOR DAM.
- ALL TREES DESIGNATED FOR REMOVAL ARE TO BE REMOVED AT 3" ABOVE GRADE.
- NO SOIL IS TO BE DISTURBED AS PART OF TREE REMOVAL.

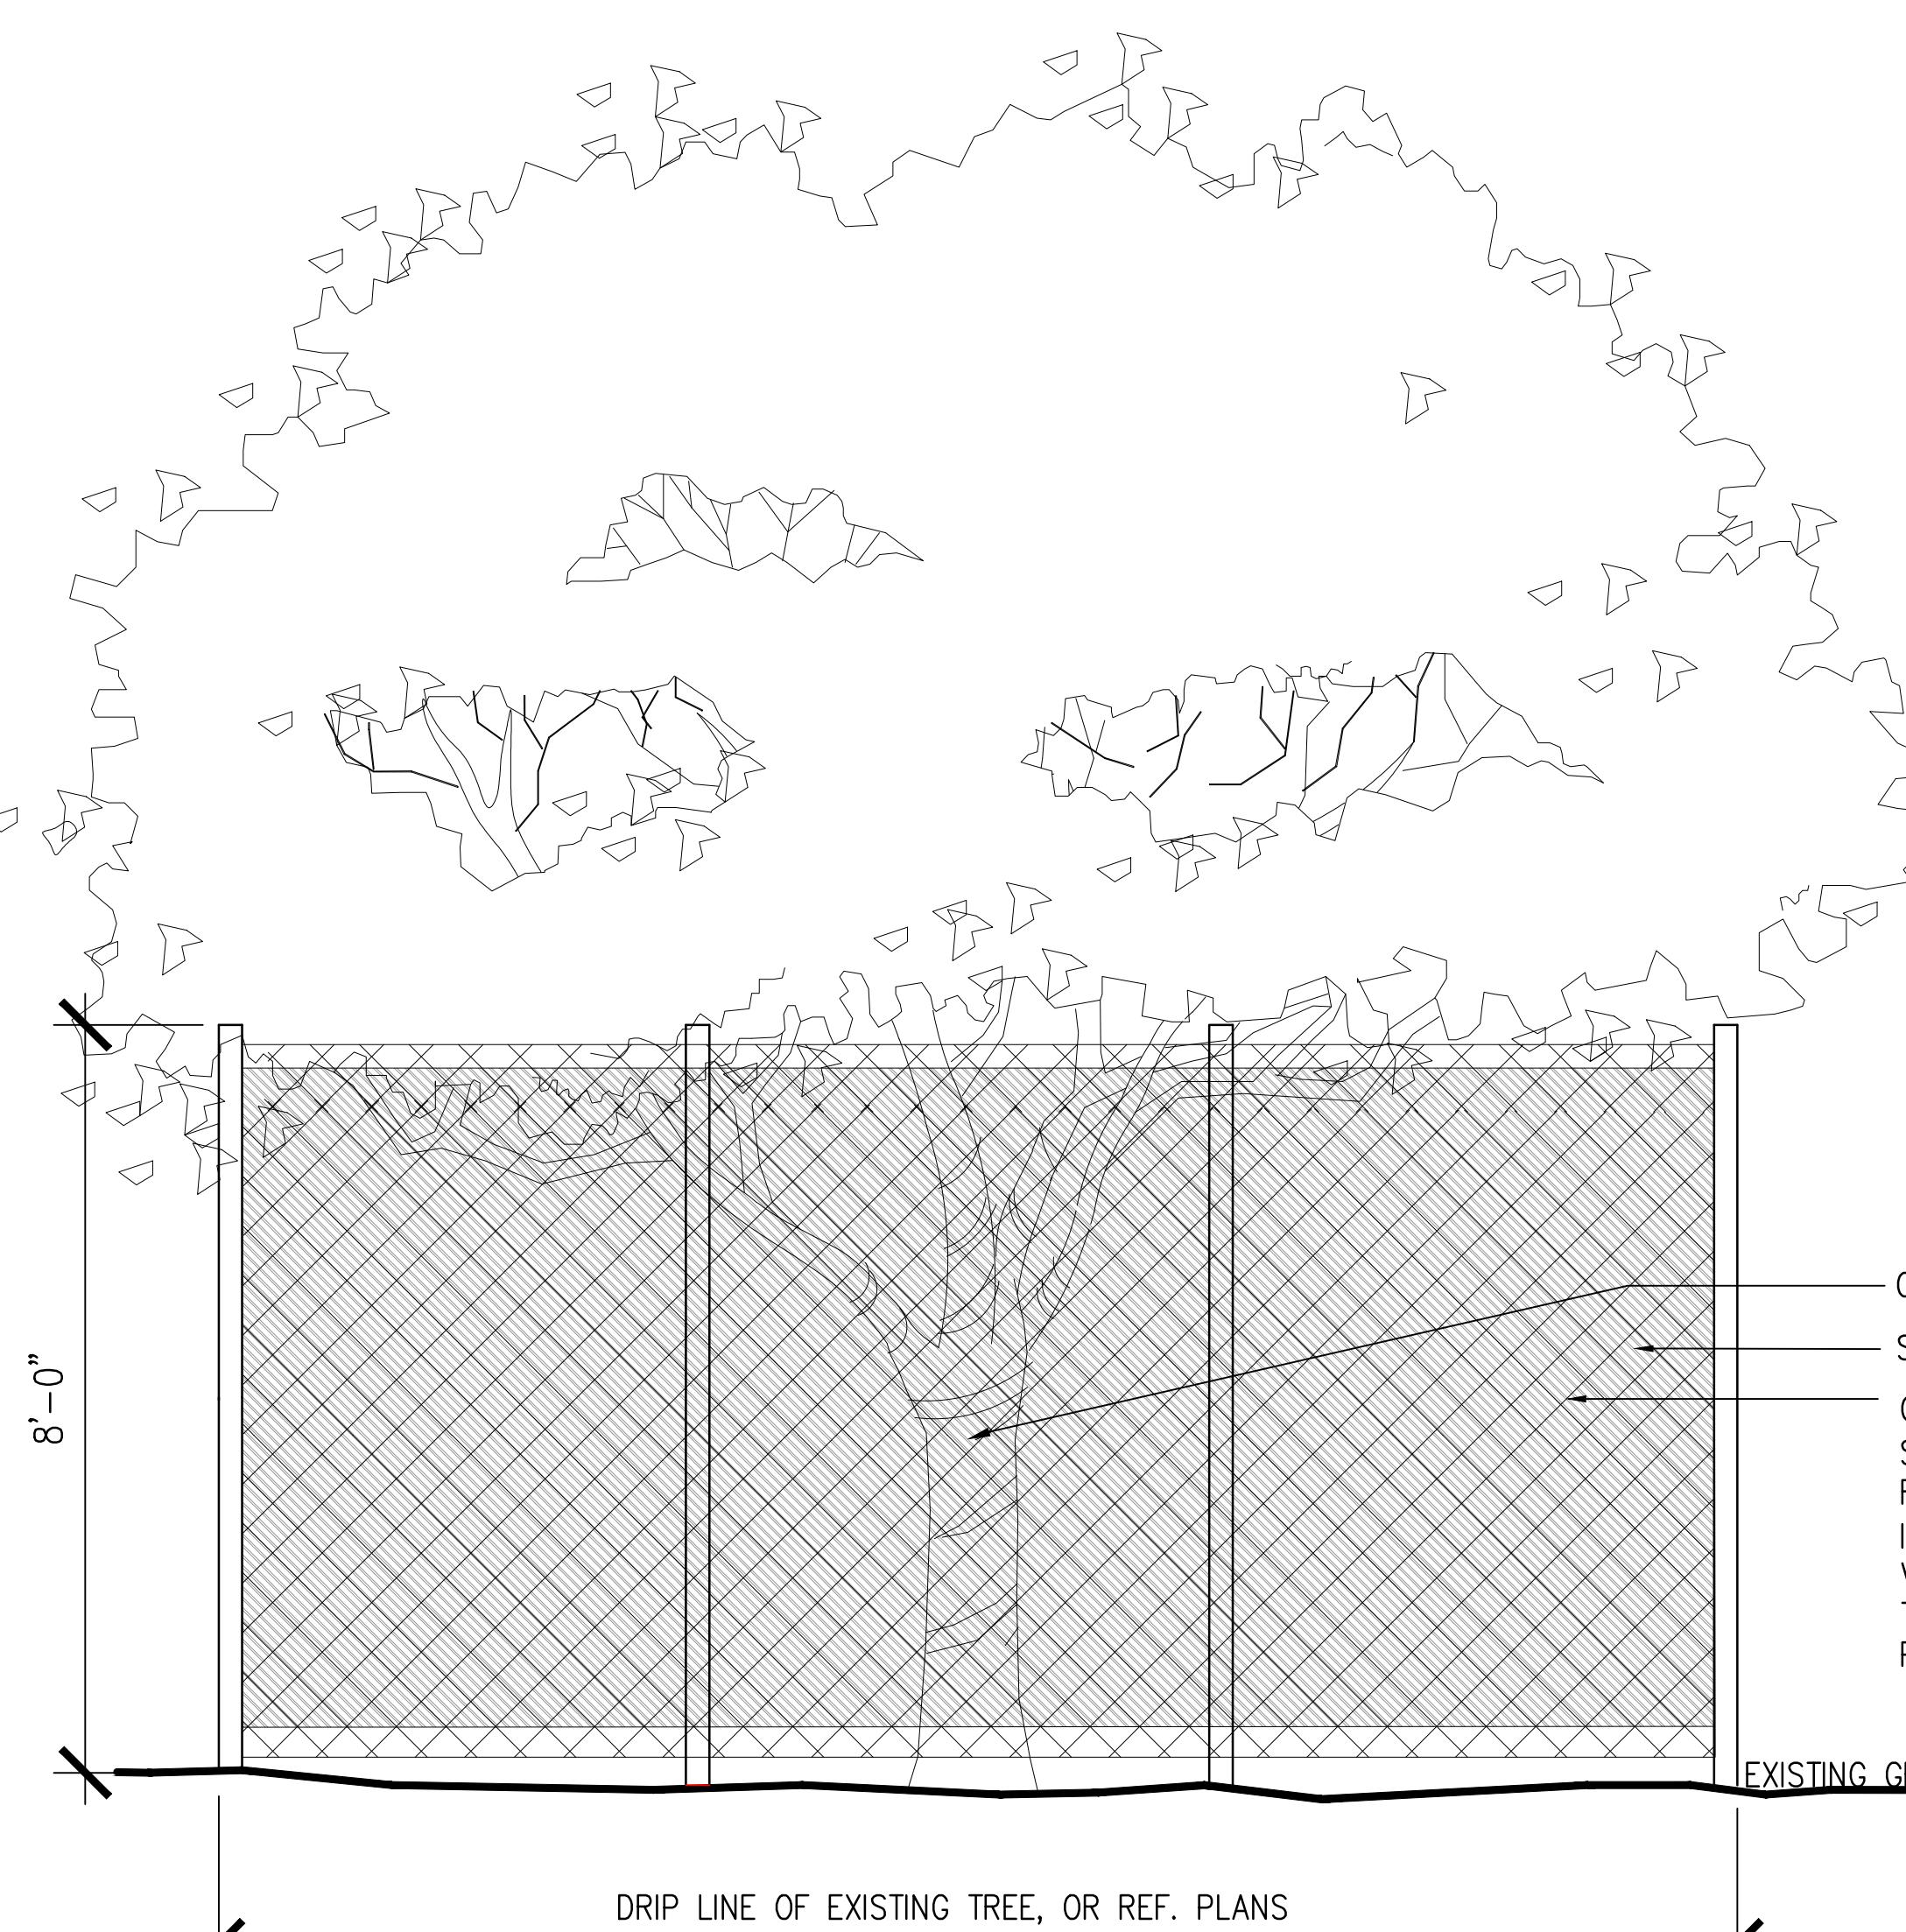
01 TREE FENCE
1 1/2" = 1'-0"

- ALL TREES INDICATED ON THE TREE PRESERVATION PLANS TO BE PROTECTED SHALL BE PROTECTED WITH TEMPORARY FENCING THROUGHOUT CONSTRUCTION.
- TREE PROTECTION FENCES SHALL BE INSTALLED PRIOR TO THE COMMENCEMENT OF ANY DEMOLITION AND/OR SITE PREPARATION WORK (CLEARING OR GRUBBING).

- NO SOIL IS TO BE DISTURBED BY THIS SCOPE OF WORK.
- FENCES SHALL COMPLETELY SURROUND THE TREE OR CLUSTERS OF TREES; FENCES SHALL BE LOCATED AT THE OUTERMOST LIMITS OF THE TREE BRANCHES (Drip Line) AND SHALL BE MAINTAINED THROUGHOUT THE CONSTRUCTION PROJECT. FENCES MAY BE MOVED OR REMOVED TO ENABLE THE PROGRESS OF CONSTRUCTION ONLY AS APPROVED BY THE LANDSCAPE ARCHITECT.

- WHERE EXCEPTIONS RESULT IN A FENCE BEING CLOSER THAN 4 FEET TO A TRUNK, PROTECT THE TRUNK WITH STRAPPED-ON PLANKING TO A HEIGHT OF 8' (OR TO THE LIMITS OF THE LOWER BRANCHING) AS INDICATED ON TREE PRESERVATION PLANS.
